Technical Memorandum No. MERL-2012-11

Coatings for Mussel Control — Three Years of Laboratory and Field Testing

U.S. Department of the Interior
Bureau of Reclamation
Technical Service Center
Denver, Colorado

March 2012

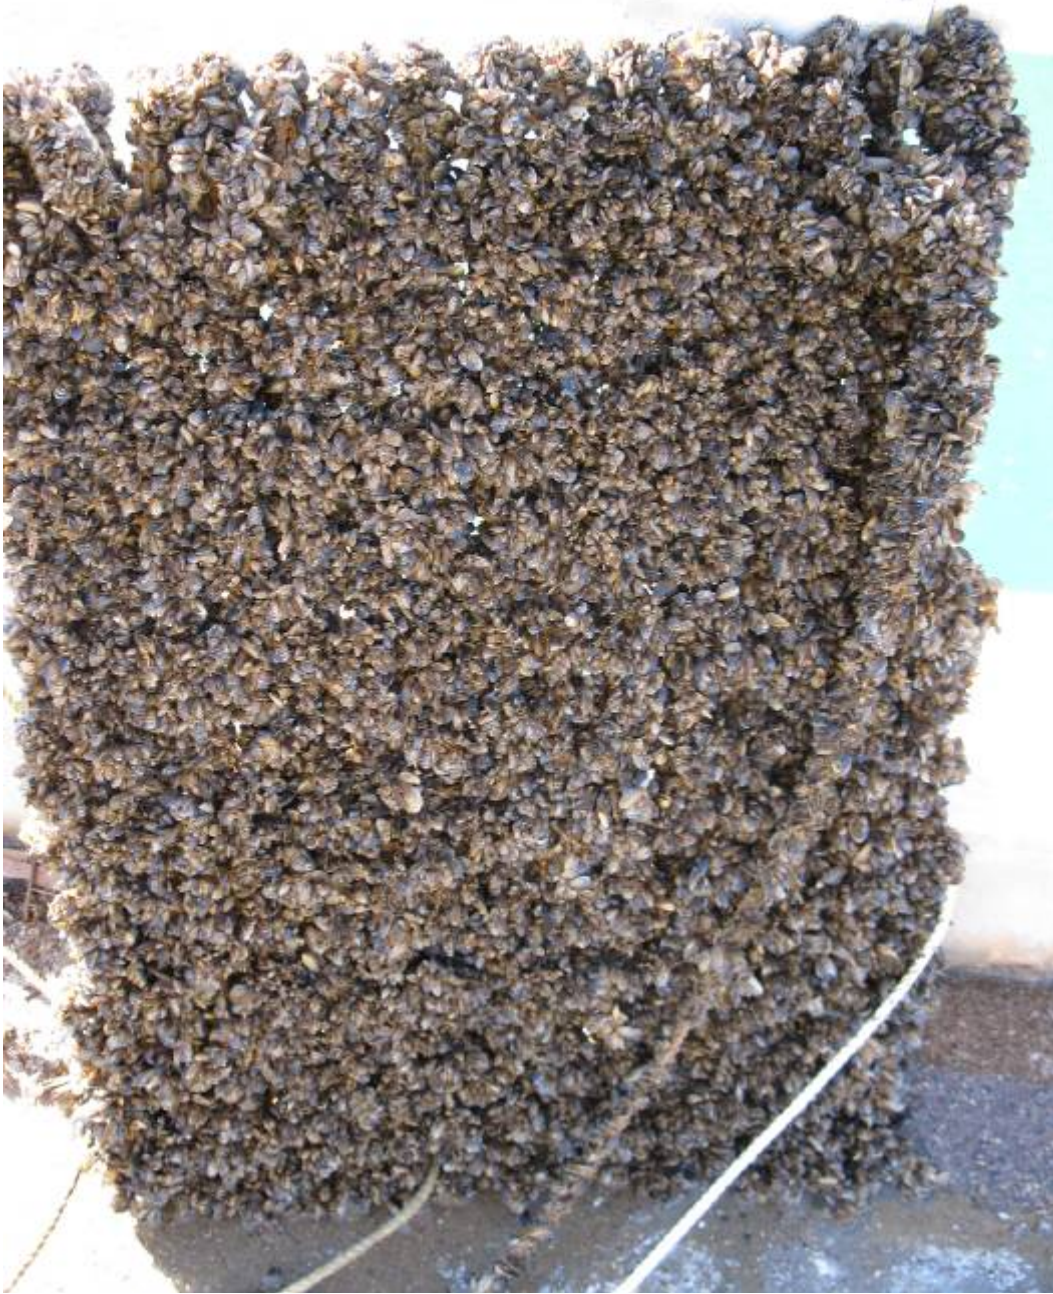
Figure 4.—Uncoated steel after 7 months of exposure in dynamic conditions. Test period May 2008 to December 2008.

ASTM A788 steel and 304 stainless steel were used to verify the presence of mussels and to determine a fouling rate to be compared to coatings.[5] Both steel and stainless steel foul quickly; within a year the mussel completely block the grate so no water was flowing through the 1-inch openings. Over 1.7 pounds of force was needed to remove a single mussel.

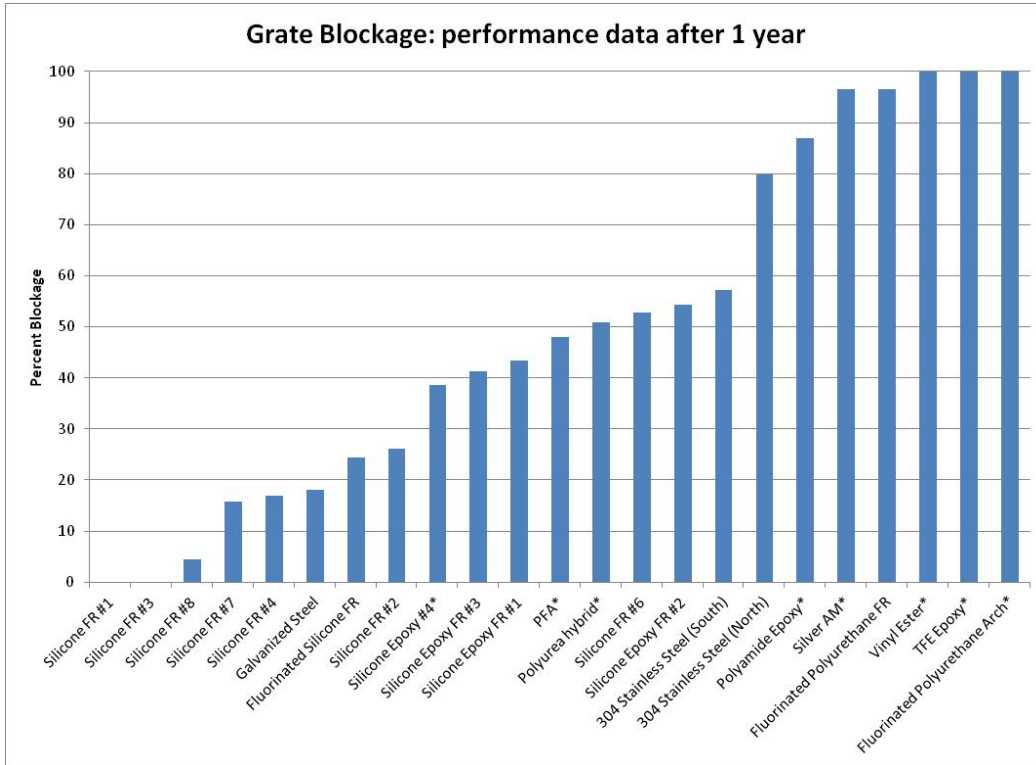
Figure 11 shows the maximum force to remove individual mussels from the coated surfaces. The force gauge instrument was very sensitive, but all readings below 0.02 pound were assigned a zero force due to increased possibility for human error. Figures 12 and 13 show blockage after 1 and 2 years, respectively.

Figure 12.—Performance data for grates after 1 year of exposure.

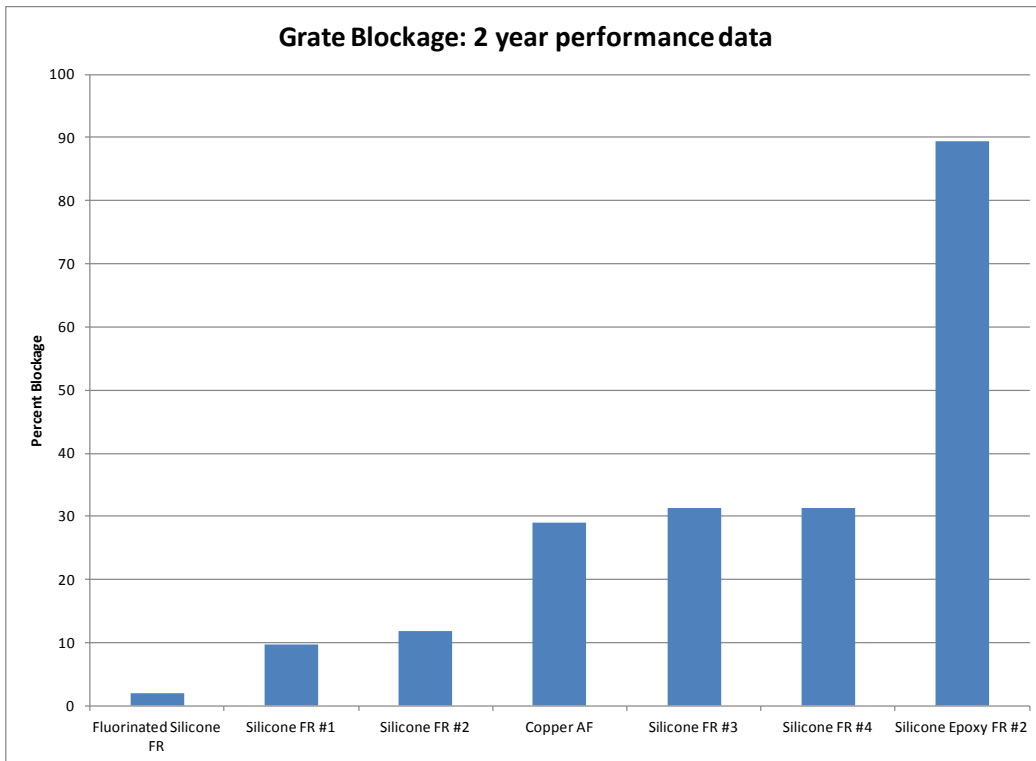
Figure 13.—Performance data for grates after 2 years of exposure.

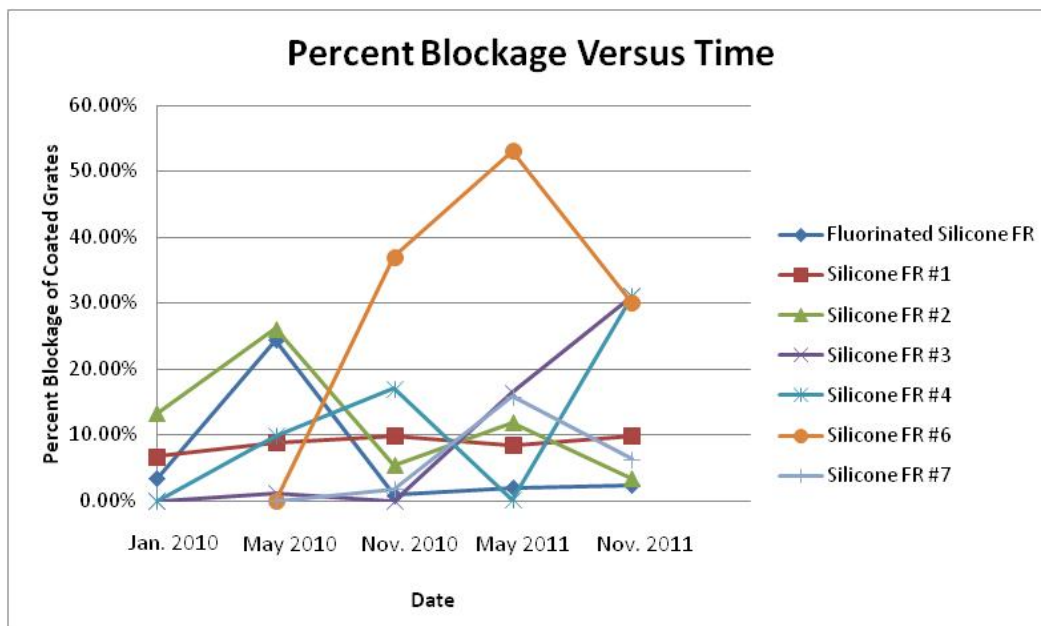
accumulation of algae, slime, and bryozoans. Quagga mussels do not attach to the silicone surfaces. For some foul release coatings, there was a decrease in percent blockage of the grate from season to season as seen in figure 14. The silicone and fluorinated silicone foul release coatings showed releases once fouling had built up enough for drag forces to exceed the bond strength and peel the fouling off the surface. Another possible explanation is that during the summer months flow rates and hence velocities are higher due to an increased power demand (peaking power) and water demand for irrigation which subjects the fouling to larger shear forces. During fall inspections, there was significantly less fouling on the silicone and fluorinated silicone foul release coatings than during the spring inspections. The velocity range during the summer months (or when all units are operating) was between 1.8 and 2.4 ft/s. The sloughing off has only been documented with the silicone and fluorinated silicone foul release systems.

Figure 14.—Percent blockage of the silicone foul release coatings seasonal variation.

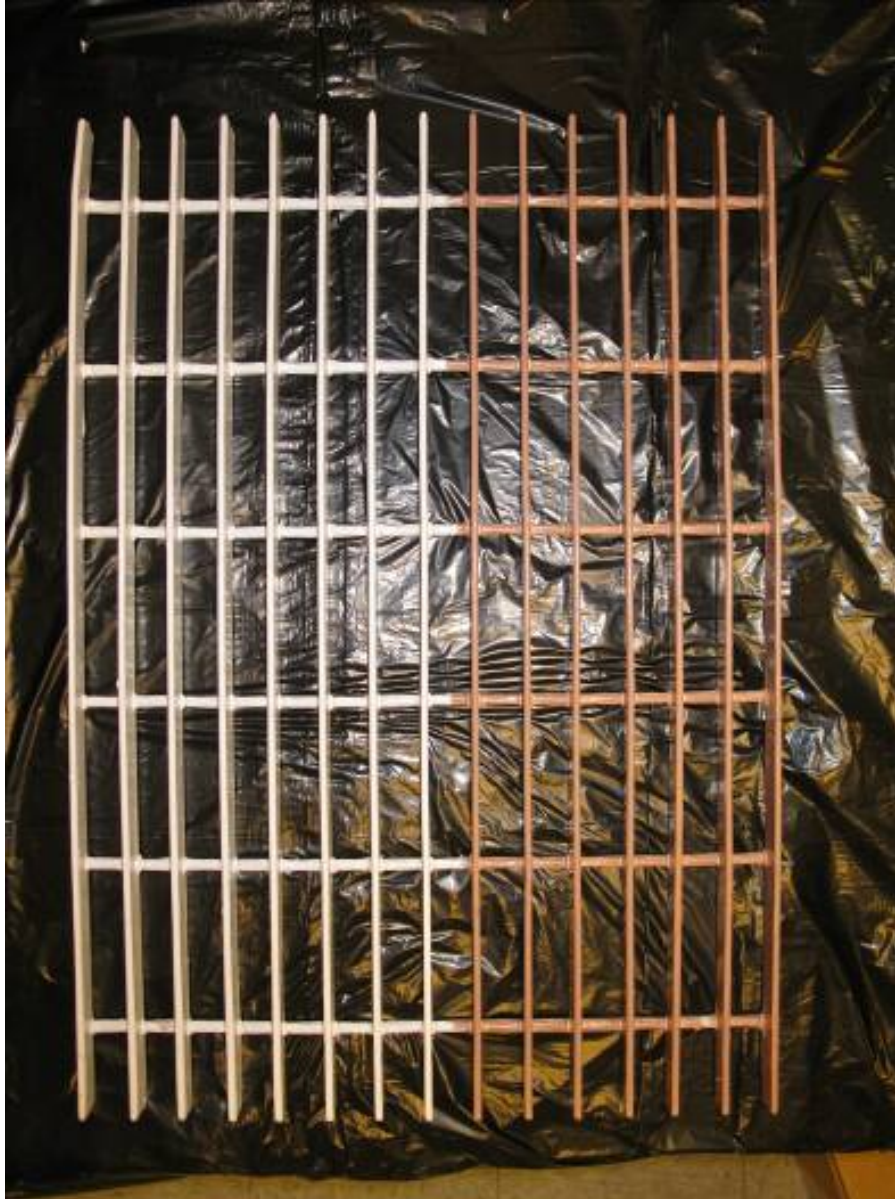
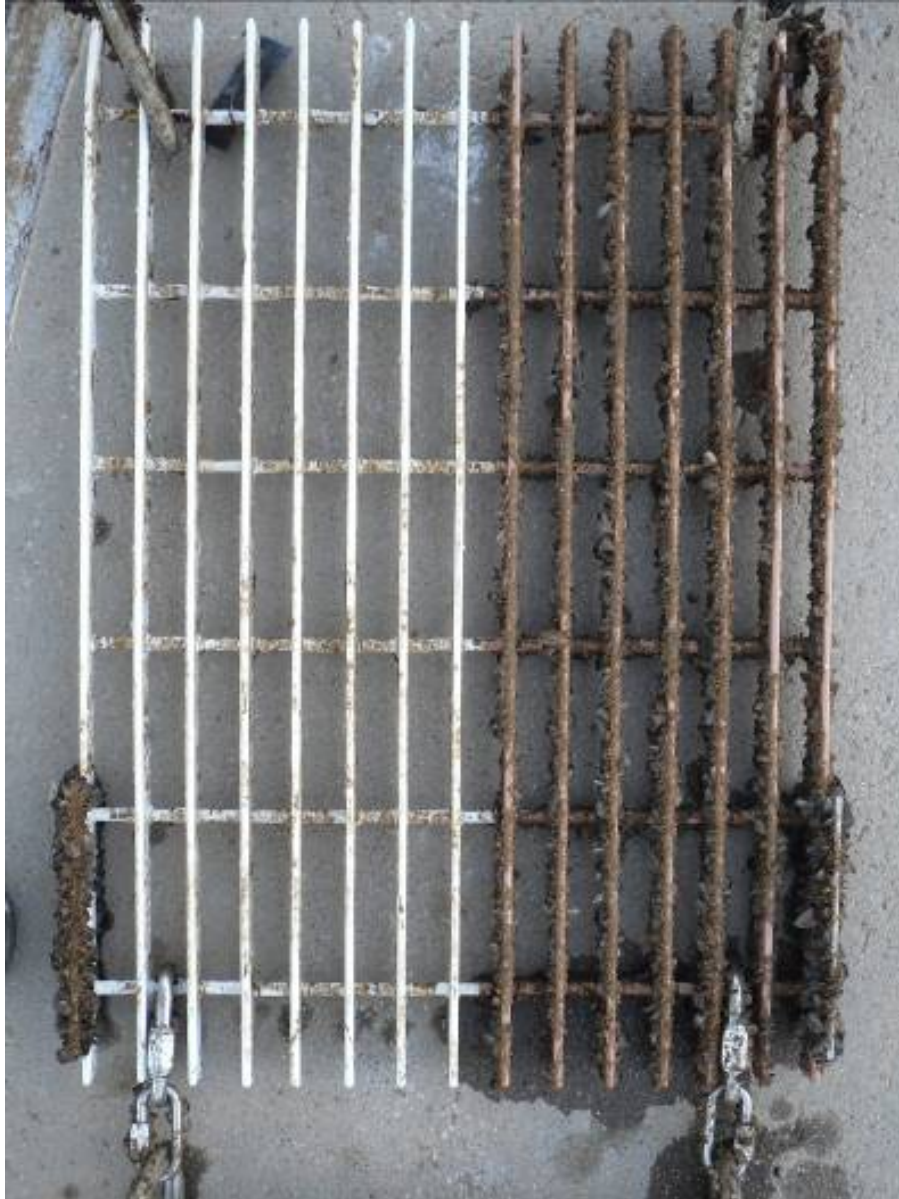
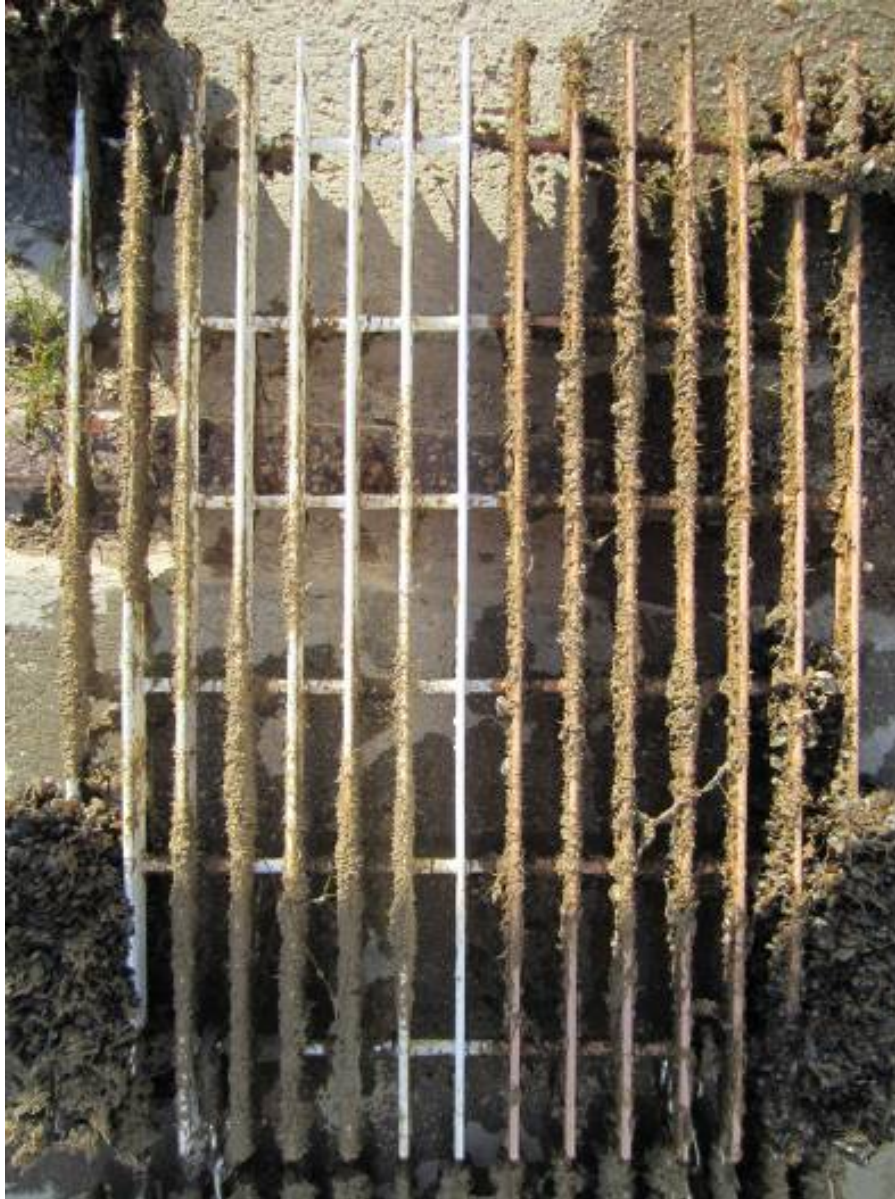
The silicone FR #6 is actually a tie coat of one of the silicone foul release coatings and does not release the fouling as easily as the silicones. Figure 11 shows that the mussels barely attach to the surface of the tie coat (silicone FR#6 requiring only 0.02 pound of force to remove a mussel). This was the lowest measureable force for any of the coatings tested that actually allowed the mussels to attach to the surface. This coating system was selected to demonstrate the self-cleaning process. Silicone FR #6 fouled up to approximately 25 percent from May 2010 to November 2010 as shown in figures 15 and 16. Between November 2010 and May 2011, Silicone FR #6 fouled up to 50 percent as shown in figure 17. Sometime between May 2011 and November 2011, the mussels sloughed off and the November inspection showed the grate to only be 17 percent blocked as shown in figure 18. There appears to be a critical flow rate or drag force when the fouling sloughs off. It is well known that the critical flow rate for mussels to attach to any surfaces is 4.9 ft/sec [5]. Therefore, it can be assumed that there are different critical flow rates for fouling to be released from the various types of foul release coatings. We believe that the force to remove mussels is dependent

Figure 15.—Silicone FR #6 on the right and Silicone FR #7 on the left prior to exposure (May 2010).

Figure 16.—Silicone FR #6 on the right and Silicone FR #7 on the left after 6 months in dynamic exposure (November 2010).

Figure 17.—Silicone FR #6 on the right and Silicone FR #7 on the left after 1 year in dynamic exposure (May 2011).

Figure 18.—Silicone FR #6 on the right and Silicone FR #7 on the left after 18 months in dynamic exposure (November 2011).

upon the flow rate and/or drag forces. Either the fouling needs to build up to a certain thickness or the flow rates need to be increased in order to remove the fouling. Silicone FR #6 and FR #7 were used in a waterjetting study in December 2011 and test panels were very easily cleaned.

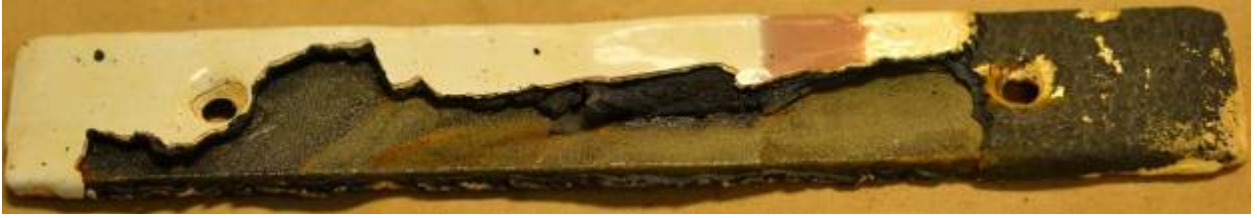
All four coating systems used to overcoat coal tar experienced failures in the high flow test. Typically, the coal tar experienced a disbondment from the metallic substrate on the overcoated portion as shown in figure 23. Neither static immersion in a dilute Harrison solution or in deionized water produced catastrophic failure, but cracking was observed in several samples along the interface between coal tar enamel and the primers. It is believed that internal stresses, perhaps due to expansion/contraction of the primer and subsequent layers, caused the low strength coal tar enamel to fail. It is unlikely this problem is unique to foul release coating systems, but the extra coats that were required may aggravate the effect.

Figure 23.—Failure of overcoated coal tar during a high flow test.

Several foul release coatings outperformed the epoxy controls in erosion testing, but abrasion resistance was much lower. Failure of one of these tests does not automatically eliminate a coating system from consideration, but it is important to recognize each product's limitations when developing performance specifications. Successful deployment of a silicone-based foul release coating will depend strongly on the service environment. Environments where silicone-based foul release coatings have contact with equipment or floating debris is likely should be avoided. Silicone epoxy coatings appear to be more resistant to this type of abrasion damage. None of the coating systems are recommended for application over coal tar enamel.
