Technical Memorandum No. MERL-2012-11

Coatings for Mussel Control — Three Years of Laboratory and Field Testing

U.S. Department of the Interior
Bureau of Reclamation
Technical Service Center
Denver, Colorado

March 2012

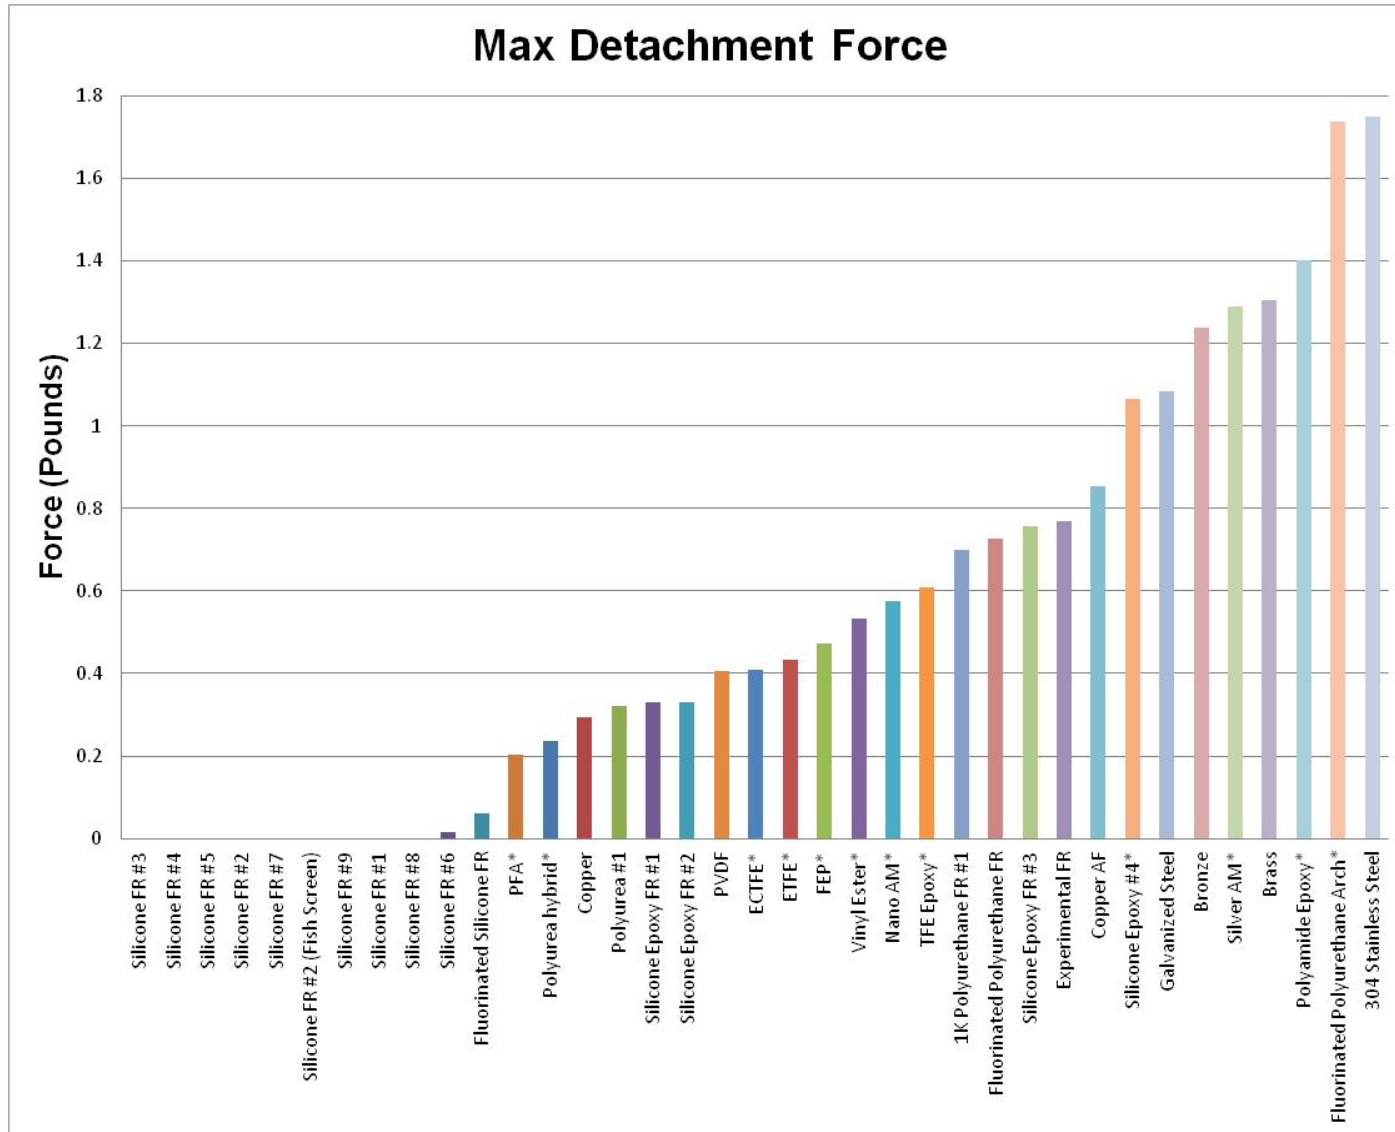
Figure 11 shows the maximum force to remove individual mussels from the coated surfaces. The force gauge instrument was very sensitive, but all readings below 0.02 pound were assigned a zero force due to increased possibility for human error. Figures 12 and 13 show blockage after 1 and 2 years, respectively.

Figure 11.—Maximum attachment force on coated test plates suspended in static water. The symbol * means that the coating is not marketed specifically for fouling control.

The silicone FR #6 is actually a tie coat of one of the silicone foul release coatings and does not release the fouling as easily as the silicones. Figure 11 shows that the mussels barely attach to the surface of the tie coat (silicone FR#6 requiring only 0.02 pound of force to remove a mussel). This was the lowest measureable force for any of the coatings tested that actually allowed the mussels to attach to the surface. This coating system was selected to demonstrate the self-cleaning process. Silicone FR #6 fouled up to approximately 25 percent from May 2010 to November 2010 as shown in figures 15 and 16. Between November 2010 and May 2011, Silicone FR #6 fouled up to 50 percent as shown in figure 17. Sometime between May 2011 and November 2011, the mussels sloughed off and the November inspection showed the grate to only be 17 percent blocked as shown in figure 18. There appears to be a critical flow rate or drag force when the fouling sloughs off. It is well known that the critical flow rate for mussels to attach to any surfaces is 4.9 ft/sec [5]. Therefore, it can be assumed that there are different critical flow rates for fouling to be released from the various types of foul release coatings. We believe that the force to remove mussels is dependent

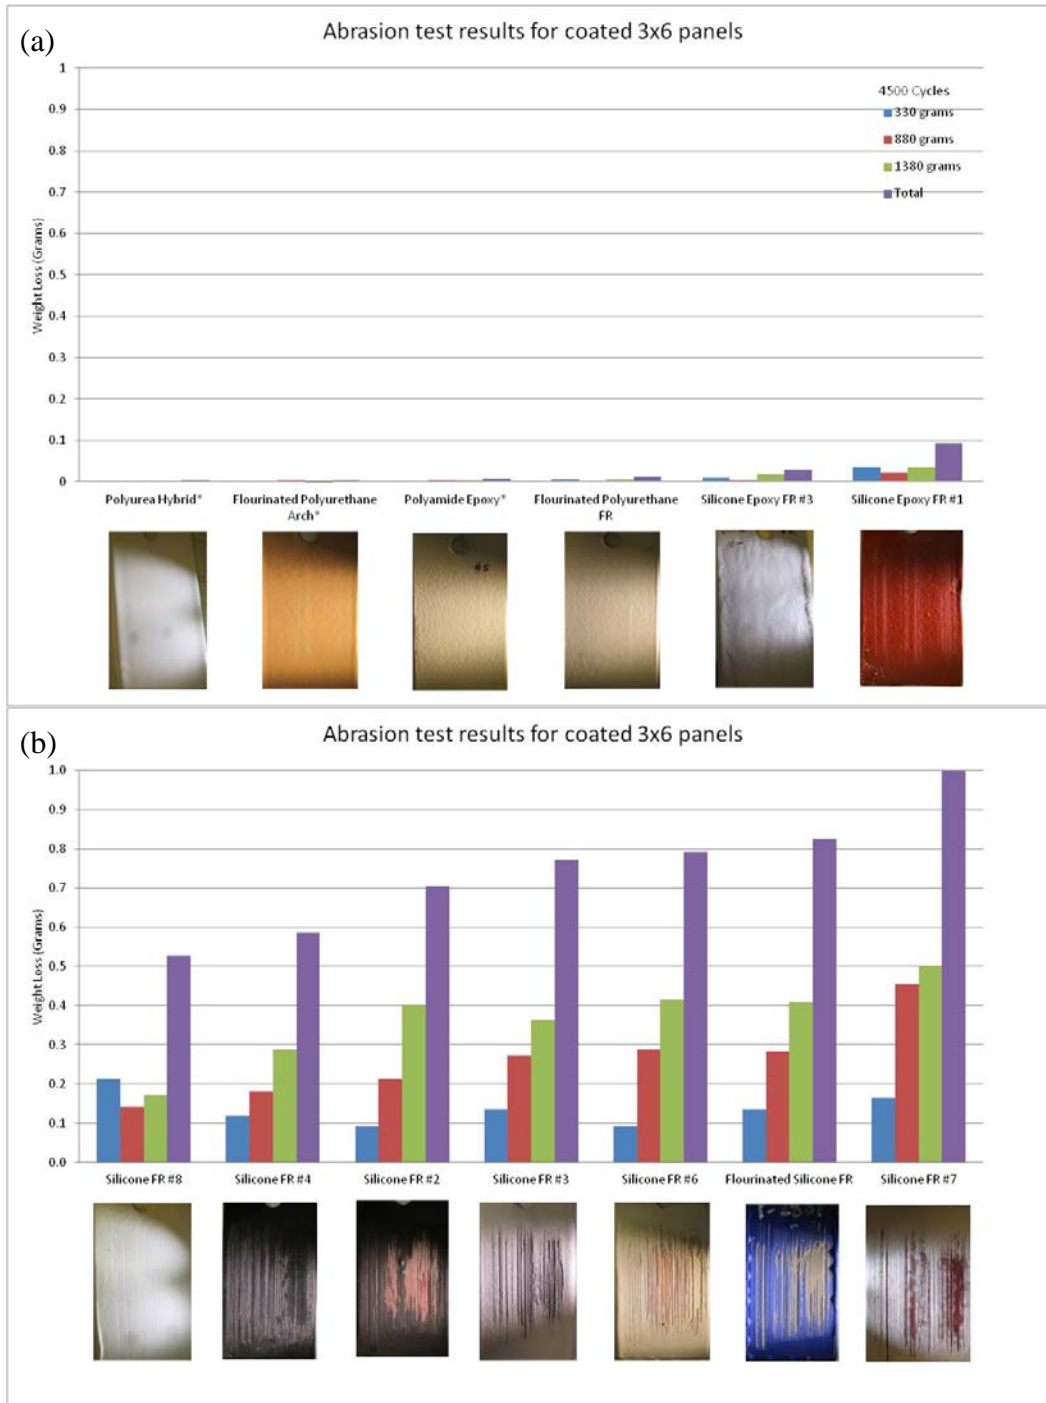
In general, the harder coatings were far more durable than the softer coatings. However, one notable exception was the polyurethane-urea hybrid control sample, which was both soft and durable. The abrasion test results for the more durable coatings are given in figure 22a; results for silicone-based coatings are shown in figure 22b.

Figure 22.—Abrasion test results for (a) control samples and durable foul release coatings and (b) silicone foul release coatings.

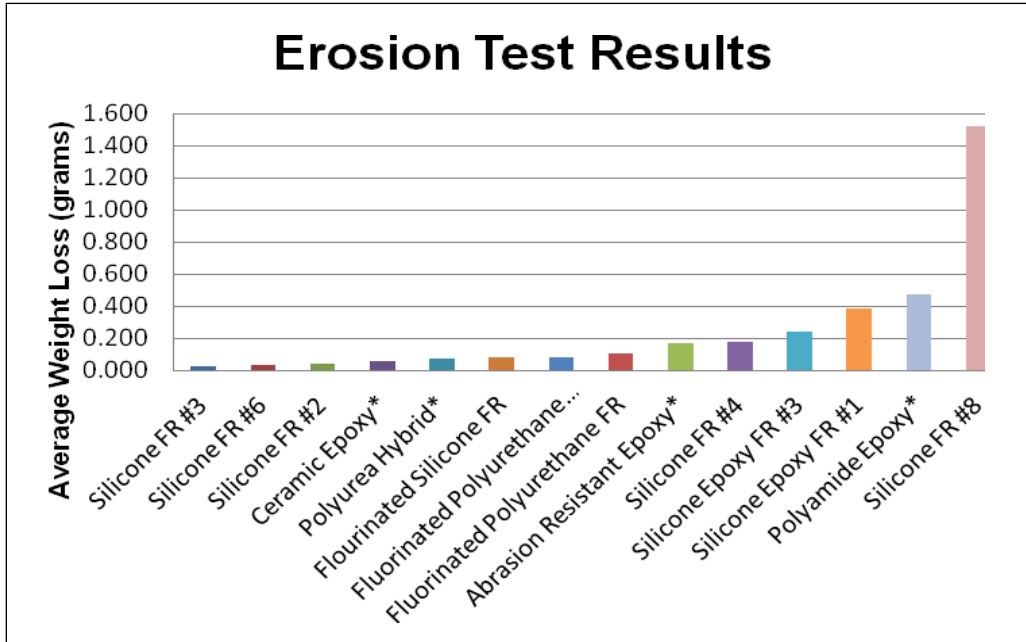
The most notable physical change observed on the samples was a loss of gloss. It was difficult to gage the damage using visual inspection, so the samples were weighed to quantify the damage. Figure 24 shows the silicone foul release coatings exhibited excellent erosion resistance, comparable to an abrasion resistant epoxy. It outperformed the polyamide epoxy by more than 10 times less weight loss. One notable exception was Silicone FR #8, which experienced damage far greater than any other coating system. Silicone FR #8 was also unique in that the cured coated panel had a very oily feel in comparison to the other samples. Some silicone foul release coatings also outperformed a ceramic epoxy specifically designed to withstand erosion. However, the densities of the materials were significantly different, and the coating thickness loss was more important than the weight loss. Unfortunately, some of the coating densities were unknown, so the data could not be compared using the calculated thickness loss.

Figure 24.—Erosion test results for foul release coatings and controls. “*” denotes non-foul release systems.
