Research Article

Marine biofouling on recreational boats on swing moorings and berths

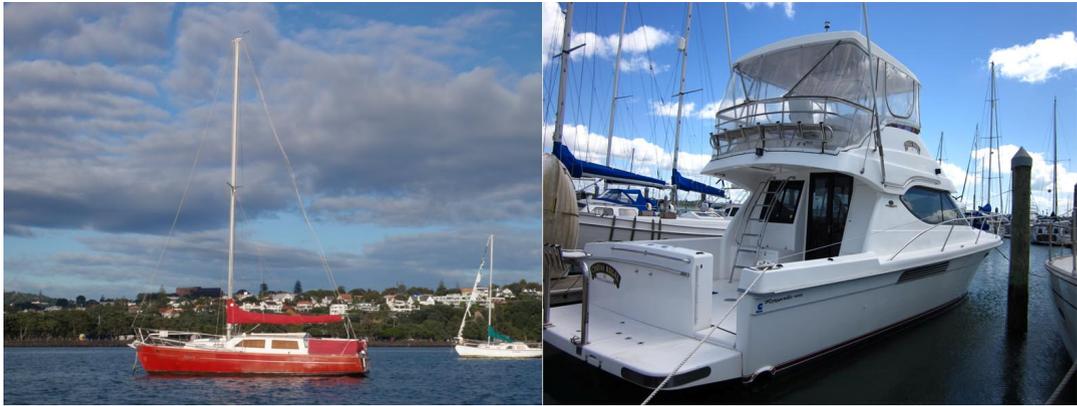
Figure 1. Examples of photos of boats on swing moorings (left) and in berths (right).

Recreational boats are typically moored either in berths (e.g. attached to a pier in a marina) or on swing moorings (attached to an anchored buoy via a rope or chain) (Figure 1; Dodgshun et al. 2007;

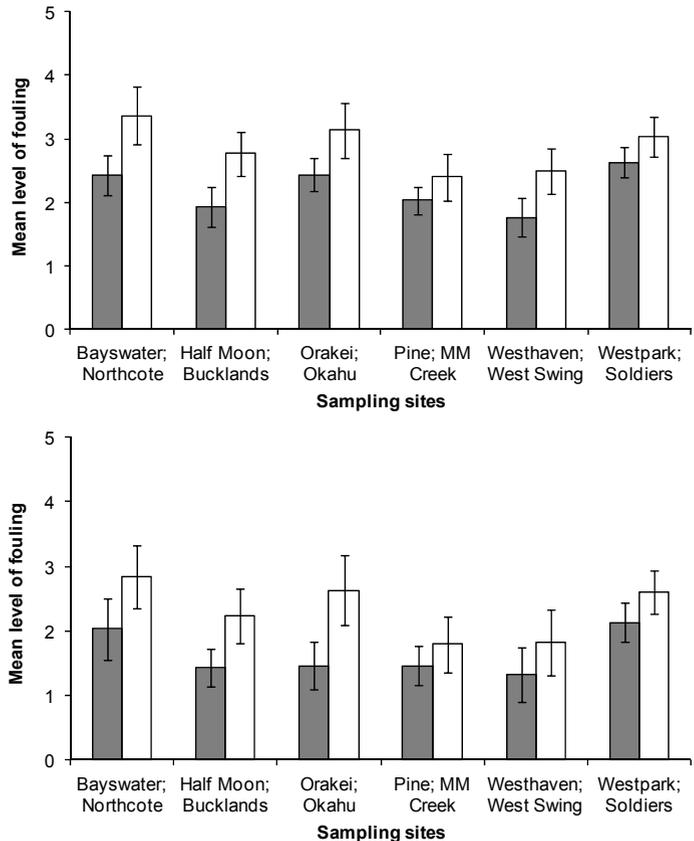
Figure 3. The mean level of biofouling assessed by video (upper panel) and visually (lower panel) for boats in berths (shaded, n = 180) and on swing moorings (clear, n = 180) across all sites. Error bars depict 95% confidence intervals.

Whether estimated by video or visual methods, the mean level of biofouling on boats on swing moorings was significantly higher than those in berths: i.e. biofouling rank of (a) 2.9 ± 0.16 (95% CL) for swing moorings and 2.3 ± 0.19 for berths by video; and (b) 2.2 ± 0.12 and 1.6 ± 0.15 by visual observation, respectively (Figure 3). Significantly more boats on swing moorings had a biofouling rank of 4 ($z = 3.43, p < 0.001$) and 5 ($z = 4.84, p < 0.05$) compared to those in berths (Figure 4). In contrast, there were

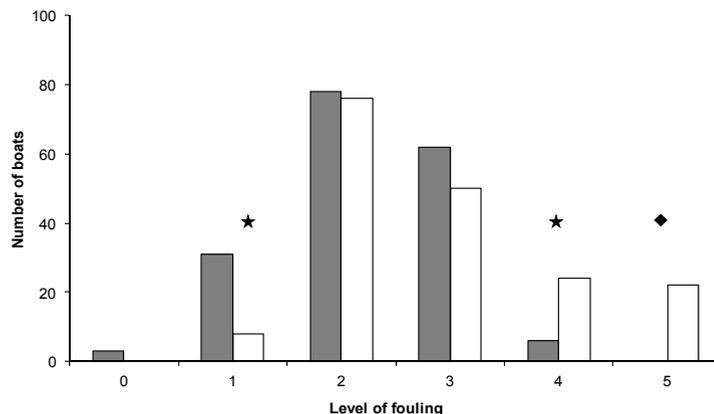
Figure 4. The distribution of biofouling on boats averaged across all sites with boats in berths and on swing moorings. A star indicates a significant difference of $p < 0.001$ and a diamond indicates a significant difference of $p < 0.05$ between boats in berths (shaded, $n = 180$) and on swing moorings (clear, $n = 180$) within each level of biofouling.

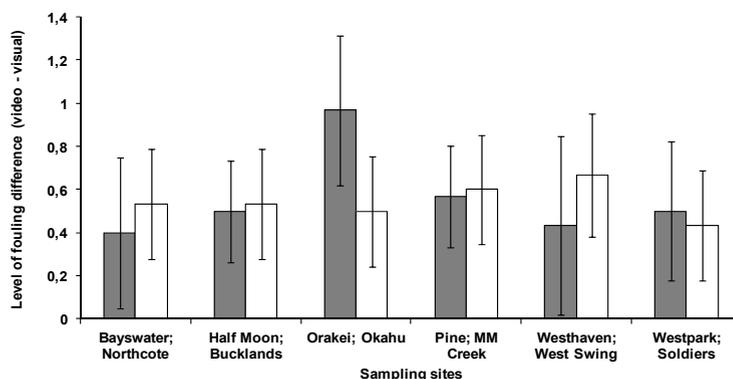
Figure 5. Difference (video – visual) in the mean level of biofouling between video and visual technique across all sites with boats in berths (shaded, $n = 180$) and on swing moorings (clear, $n = 180$). Error bars depict 95% confidence intervals.

significantly more boats with a biofouling rank of 1 in berths than on swing moorings ($z = 3.9, p < 0.001$). Although both video and visual techniques showed the same pattern of biofouling across boats, they were significantly different (paired t-test. $t_{359} = 13.38, p < 0.001$) (Figure 5).

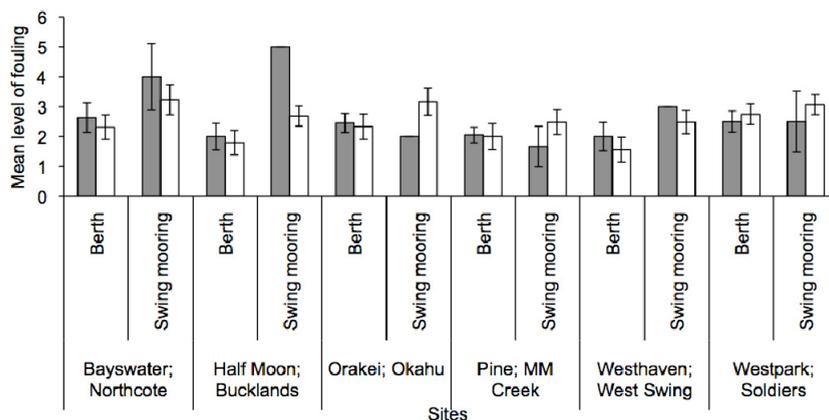
Figure 6. The mean level of biofouling across sites by mooring and boat type (launch (shaded) or yacht (clear)). Error bars depict 95% confidence intervals. Columns with no error bars indicate only one boat within that boat type.

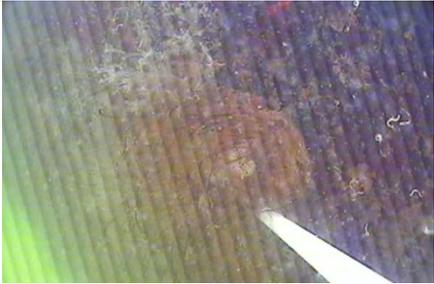
Location	Species found	Images
Bayswater (berth)	Possibly <i>Botrylloides leachii</i>

Table 3. Species identified from the still images obtained from the video on boats on swing moorings and in berths.

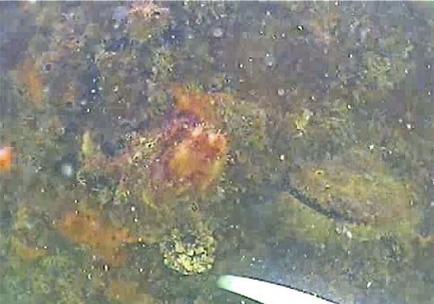
Buckland's (swing mooring)	Possibly <i>Styela canopus</i> and <i>Ascidia aspersa</i>

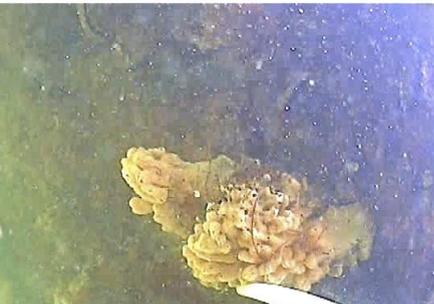
Okahu (swing mooring)	<i>Styela plicata</i> , possibly <i>Botryllus schlosseri</i>

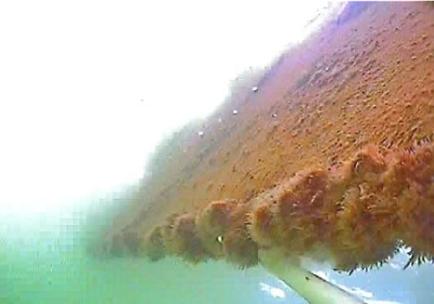
MM Creek (swing mooring)	Possibly Botryllid tunicate

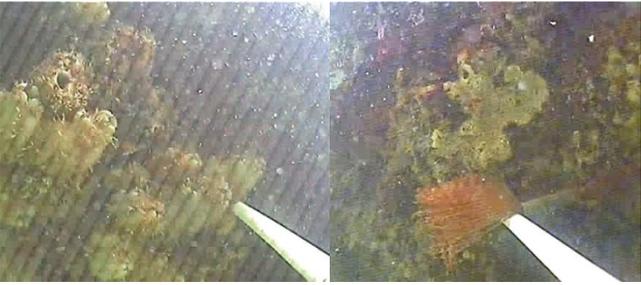
Westhaven (berth)	Possibly <i>S. plicata</i> (left), <i>S. spallanzanii</i> (right).
